# North Colchester Sites A, B & C

## Tree Survey Report

Project number: 60689516  
60689516-ACM-ARB-XX-RP-EN-3000001

June 2025

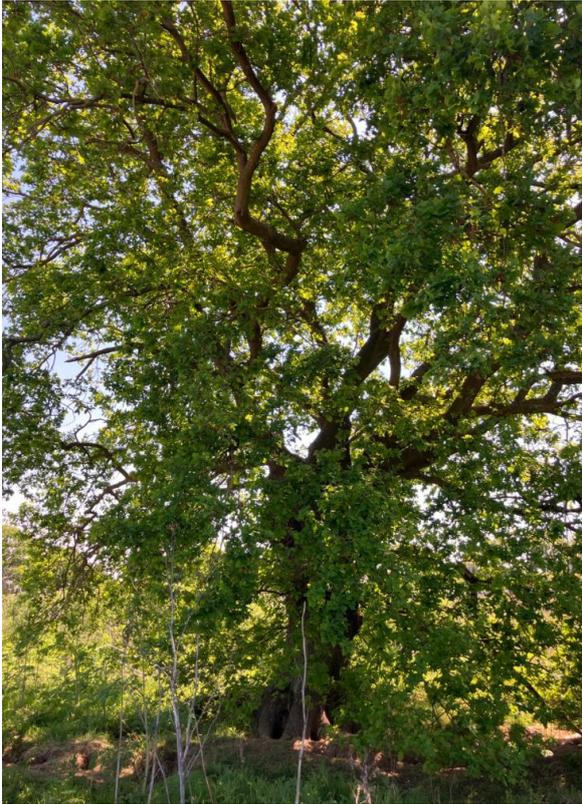
Photo 1. Veteran tree T62.

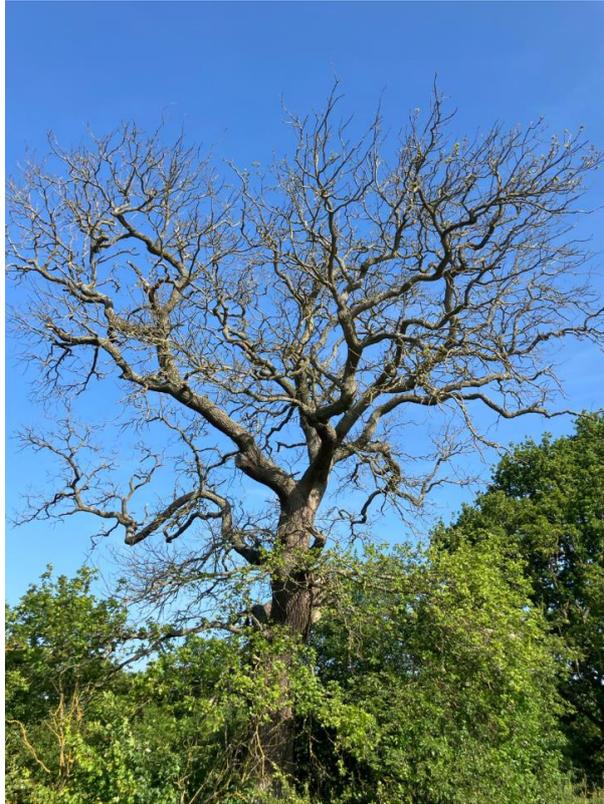
T29*	Common Oak (Quercus robur)	10	970	8	8	8	8	3.5/N	6	Poor	M	Fair	Moribund. Significant crown dieback throughout. Very few leaves at time of survey. Secondary lower crown development to circa 4m. Soil erosion and buttressing at base. Cavity at base (northeast) circa 250mm deep. Black exudate/bleeding to stem, potential acute oak decline. Mature dead tree so could	Test for acute oak decline/ Phytophthora (3 months).  Consider monolith to circa 4m to reduce risk of failure, leaving live lower crown. (< 3 months)	<10	U1	11.64m

Photo 2. Tree T29.

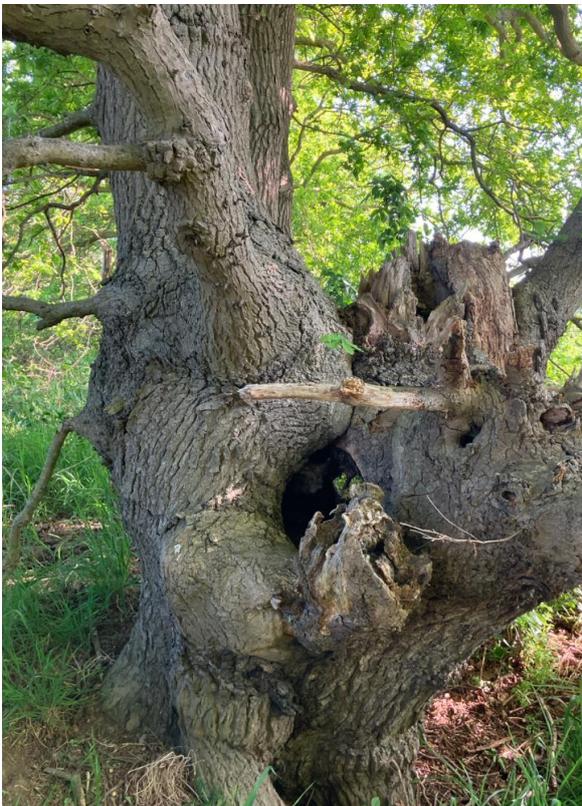
T21*	Common Oak (Quercus robur)	15	1200,390,420	5	3	6	7	1.0/S	2	Good	V	Fair	Historic pollard to circa 2m. Extensive stem decay. Large open cavity at circa 1m extends horizontally through stem. North entrance 300x450mm, South entrance 250x370mm. Adjacent secondary stems are		40+	A3	19.95m

Photo 3. Veteran tree T21, looking north.

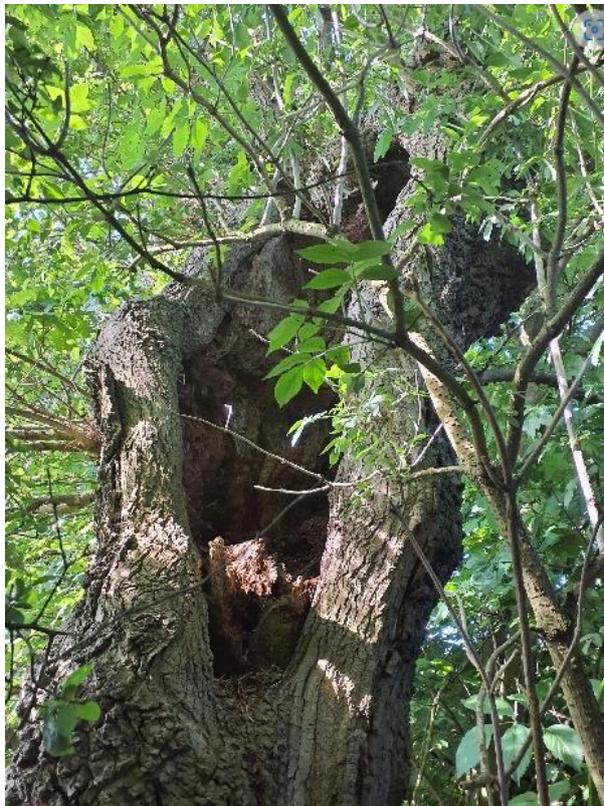
Photo 4. Veteran tree T22.
